CENTRAL INTELLIGENCE AGENCY

INFORMATION REPORT

SUBJECT Description of Road from Asunción to Paraná River

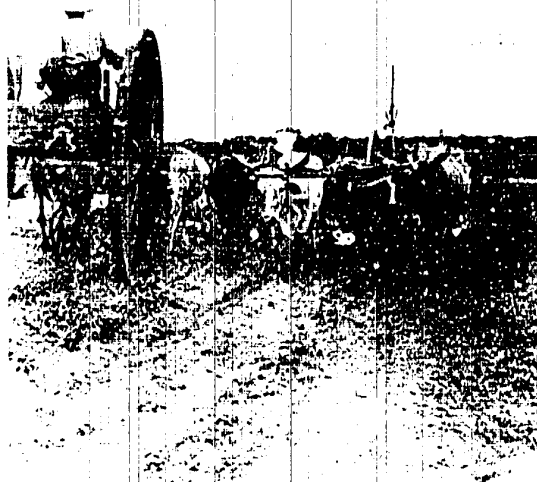
CIA PHOTO ACCESSION NO.		LOT NO.		DATE	
AREA (AMS NO.)		COUNTRY		PROVINCE	PLACE
GEOGRAPHIC COORDINATES				MAP REFERENCE	
TITLE					
(8) Logging operations					
DATE OF PICTURE		SOURCE OF PICTURE			
CLASSIFICATION					
CAPTIONED BY		VERIFIED BY			
FORM NO. 60-83 SEP 1948		CAPTION REPORT

214.9 Swamp crossed by corduroy road.
 215.8 Stream, drains southeast, log loading area. (See Photos 6 - 11)
 216.1 Gate and road junction, turn right.
 218.6 Road to left.

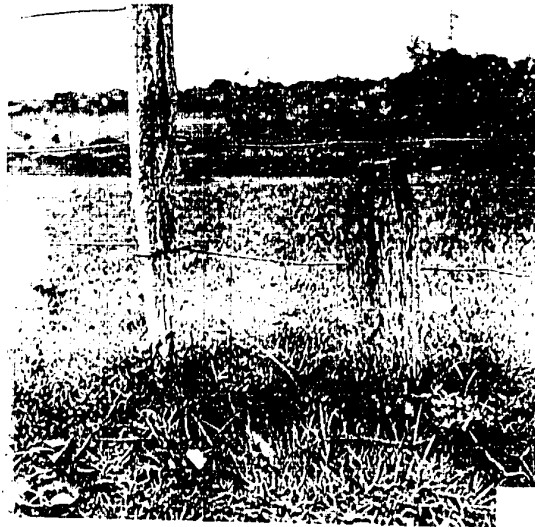
CIA PHOTO ACCESSION NO.		LOT NO.		DATE	
AREA (AMS NO.)		COUNTRY	PROVINCE	PLACE	
GEOGRAPHIC COORDINATES			MAP REFERENCE		
TITLE (20) Survey markers at corner of a building lot in Hernandezias wp					
DATE OF PICTURE		SOURCE OF PICTURE			
CLASSIFICATION					
CAPTIONED BY			VERIFIED BY		
FORM NO. SEP 1948 40-53		CAPTION REPORT
